MILES POND DAM
VT 00062

PHASE I INSPECTION REPORT
NATIONAL DAM INSPECTION PROGRAM

DEPARTMENT OF THE ARMY
NEW ENGLAND DIVISION, CORPS OF ENGINEERS
WALTHAM, MASS. 02154

DECEMBER 1980

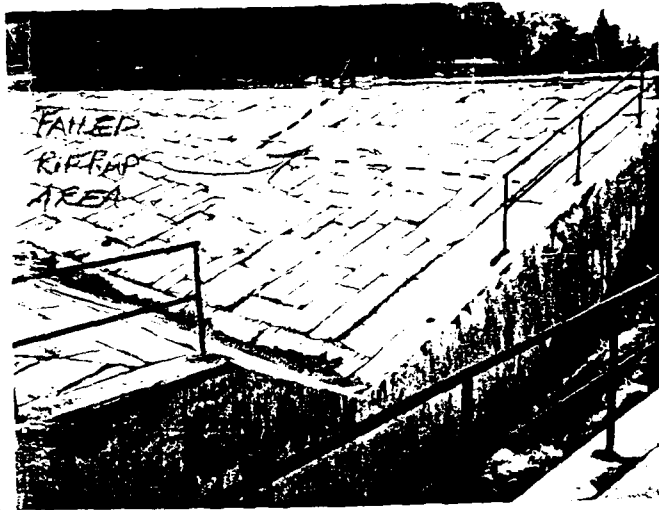
6861 MILES RD DAM - REBAR FAILURE SEPT 30, 1970

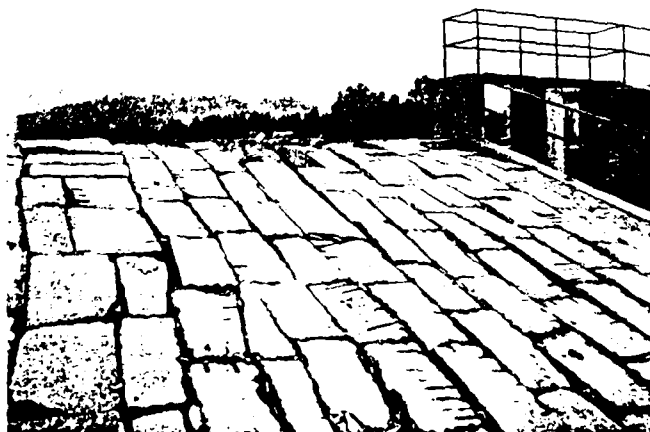
6861 MILES RD DAM - REBAR FAILURE SEPT 30, 1970
